FIELD INSPECTION

| Project Name: | Mountain Valley Pipeline | Inspector: | Matthew Grant |
| Inspection Date: | Tuesday, May 14, 2019 | Project Contact: | Brian Clauto |
| Spread: Pittsylvania County MP296-298 St15650-15739 | Spread I | Weather (Wet/Dry/Rain): | Dry |

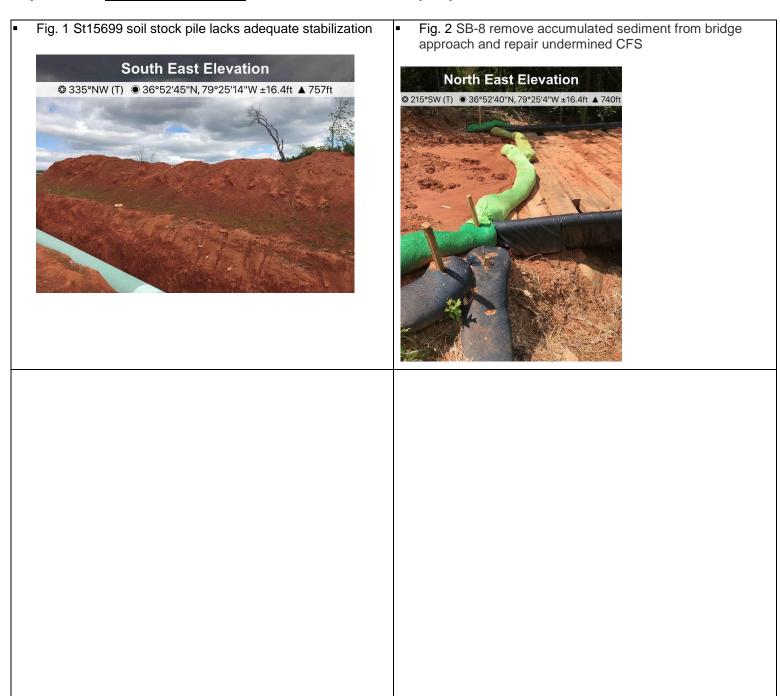
| Project Name: | Mountain Valley Pipeline | Inspector: | Matthew Grant |
|--|---|---|---|
| Streams / wetlands inspected included: S-Q4, W-Q2, S-Q3, S-Q2, SB-6, SB-8, SB-9. ECD's were in place at all inspected streams and no impacts were observed. St#15699- Soil stockpile lacks adequate stabilization Designated stream SB-8 remove accumulated sediment from bridge approach and repair undermined CFS Recommended Corrective Action: Maintain all controls per the approved plan and specs. | | | |

| Project Name: | Mountain Valley Pipeline | Inspector: | Matthew Grant |
|--|---|---|---|
| Deadline: _Within 24hr | notification | | |
